## **Customer Summary**

Newfoundland Aqua Services Ltd. (St Albans, NF Labrador)

Re: Fishnet Repair Factory

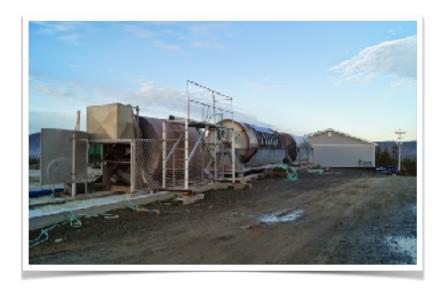
We put an Electrocoagulation treatment system followed by a DAF.

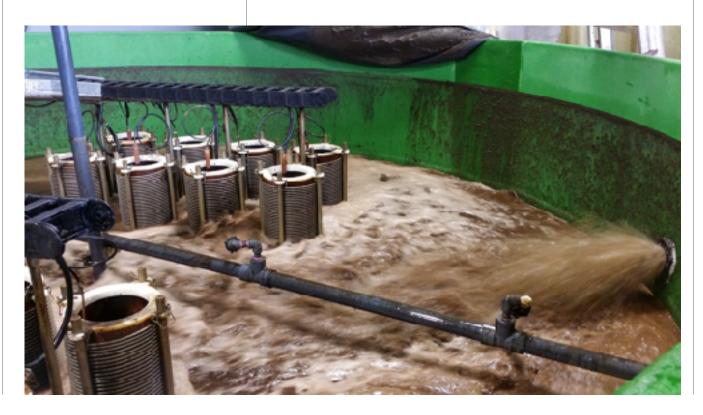
A continuous flow design system to operate between 260 and 280 GPM was put in place to change the process from evaporation to treatment and re-use of water. Evaporation was not the right method because was not only expensive but also highly corrosive on the equipment (Evaporator).

The levels of solids in the water from the fishnets that have been in the ocean for a period of 2 years is very high. Now the customer can reuse the water and produce better water for the washing. Water can be changed or replaced with less frequency.
